PROTECTION BY CONCRETE AGAINST A-BOMB RADIATION  
SICKNESS IN HIROSHIMA CITY

SELECTED ARTICLES FROM THE COLLECTION OF  
INVESTIGATION REPORTS ON ATOMIC BOMB DISASTER,  
VOLUME 1, 1953.

# A-BOMB HUMAN CASUALTIES IN A BUILDING LOCATED LESS THAN 200 m FROM THE HYPOCENTER

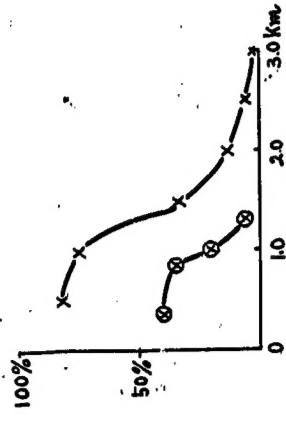
Fig. 1. Incidence of RS and distance  
from the bomb center in Hiroshima.

x -- Within the general area; O --  
within concrete buildings.

It is well known that the incidence of radiation sickness (hereafter abbreviated RS) among people who were in solid buildings at the time of the atomic bomb explosion in Hiroshima was far below that of people in the same area who were not in these same buildings. The curve marked x in Fig. 1 gives the RS incidence in the general area while the O curve gives the

incidence among people who were in concrete buildings. It was observed that concrete afforded considerable protection against RS. These curves represent average values, and there were many instances in which some people within a given concrete structure were affected by RS while others in the same structure were unaffected. It is evident that concrete attenuated the radiation from the blast. Representative concrete structures at various distances from the blast center were selected for more detailed study.

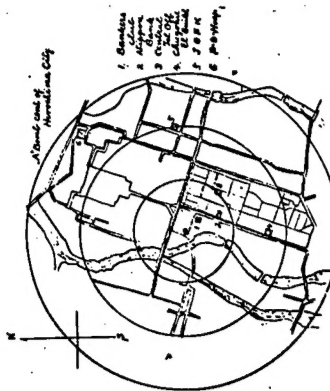
Fig. 2. Locations of buildings investigated.

(The center represents bomb center, the other circles are spaced 500 m apart.)

The sites selected for this study are the buildings shown in Fig. 2. They include 1. Bankers Club (280 m), 2. Hiroshima Branch, Bank of Japan (380 m), 3. Central Telephone Office (500 m), 4. Chugoku Power Building (800 m), 5. JOPK Studio (1000 m), and 6. Communications Office and Hospital (1350 m). (The figures in parenthesis give the horizontal distance to the blast center.)

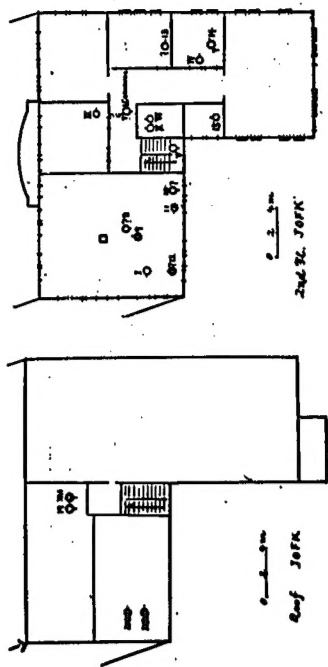
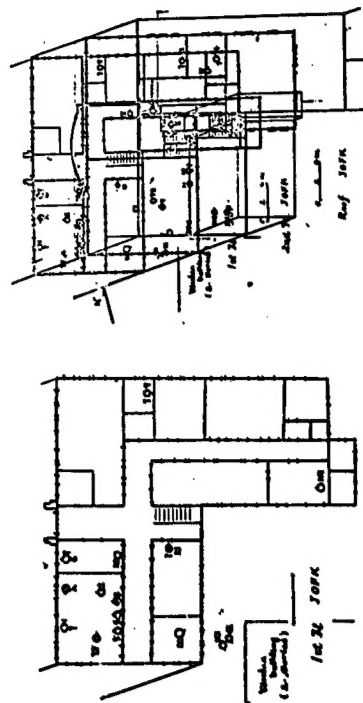
Fig. 3 (a)-(d). Injury sites at the JOFK Studio.  
(The arrows indicate the direction of the radiation)

Fig. 3 (a) Top Floor

Fig. 3 (b) Second Floor

Fig. 3 (c) First Floor

Fig. 3 (d) Transparent View.

building (Fig. 3 a), 17 and 18 were killed by exposure to the fireball. Both were stripped and had been wiping their bodies when they were exposed to the flash from the right. 17 and 18 were in the wooden addition with concrete walls that had been placed on the roof and were exposed to radiation through one concrete wall but not to the fireball. Both began to lose the hair on their heads from about the end of August. The effective shielding by the concrete for these two as determined by the method previously cited was 18 cm. (The outside of this addition had burned, and the thickness of the wood was subtracted from the thickness of the remaining concrete wall. The angle of incidence of the radiation upon this wall was taken into consideration for calculating the effective thickness): 17 and 18 who were on the first floor (Fig. 3 c) developed RS, and 19 died on September 13. As seen from the floor plan of Fig. 3 d, these two must have been standing by windows to be in the direct path of the radiation. The RS situation of people at other sites was not clear. It can be deduced that an effective concrete thickness of 30 cm would prevent RS at this distance from the blast. The results obtained in a similar manner for the Chugoku Electric Building are shown in Table 2. These results show that people shielded with more than 100 cm of concrete did not develop RS while 80-90 cm could not prevent RS. The safe effective thickness for each site determined in this manner is given in Table 3.

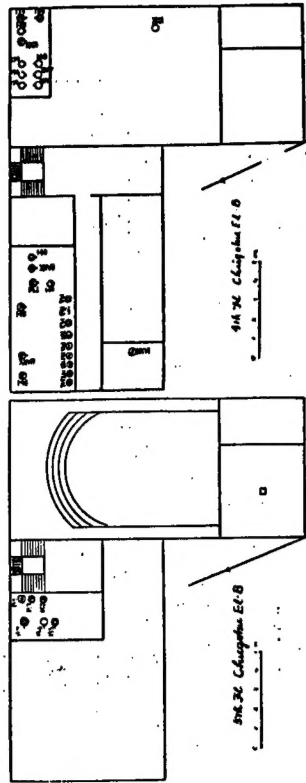
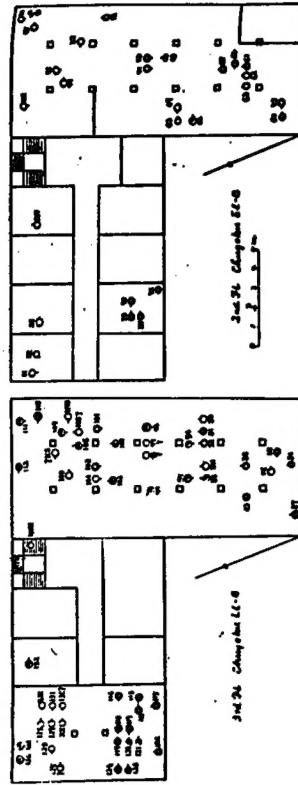
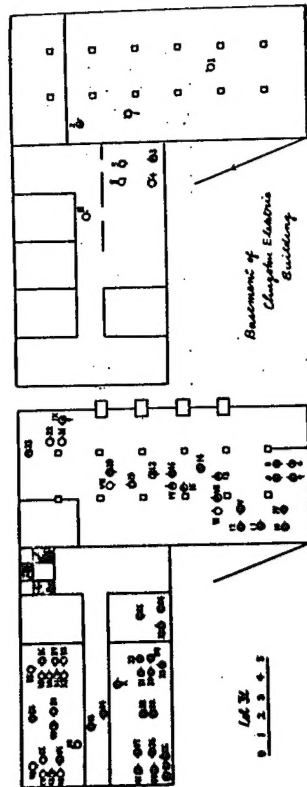
Fig. 4 (a)-(f). Injury sites at the Chugoku Electric  
Building.  
(The arrows indicate the direction of the radiation)

Fig. 4 (a) Fifth Floor

Fig. 4 (b) Fourth Floor

Fig. 4 (c) Third Floor

Fig. 4 (d) Second Floor

Fig. 4 (e)

Fig. 4 (f)

Summary of Injuries at the Chugoku Electric Building (see Fig. 4)

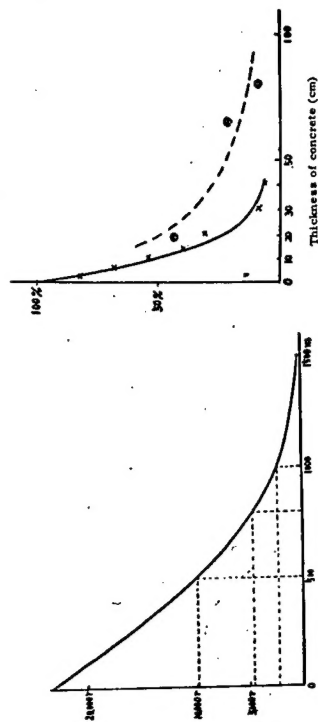
Fig. 6. External radiation dose at various distances in r units.

The radiation flux in the air at various distances from the point directly below the blast is shown in Fig. 6, and this can be considered the radiation attenuation curve in air. This dose was calculated using the number of neutrons, energy, and air attenuation factors deduced from the radioactivity of phosphorus in human bones and sulfur in fences from various parts of the city of Hiroshima along with the biological standard that a dose of 1000 r of  $\gamma$  radiation would cause loss of hair.

Consistent results were obtained for the Telephone Office, Chugan Electric Building, and the FX Studio, so these results were scrutinized further. From Fig. 6 the following dose values can be obtained:

Dose in air at the Telephone Office	10,000 r
Dose in air at the Chugoku Electric Building	4,600 r
Dose in air at the JOFX Studio	2,300 r

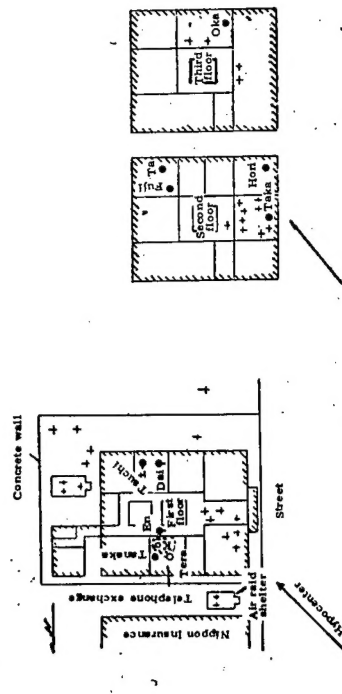
Fig. 1. First floor of the Hiroshima Bankers Club.

o -- Died later; o -- survivor; + -- instantaneous death.

4. (1) The positions of two survivors and nine who later died have been established as well as those of the 36 instantaneous deaths. (2) The records of the survivors and those who died later were plotted. (3) The effects of the radiation on the survivors were clearly manifested in the form of loss of hair, decrease in white blood cell count, temperature, vomiting, subcutaneous bleeding, or menstrual irregularity. (4) There were three people in the telephone exchange room on the first floor at the time of the explosion of which two died. One of the reasons this person survived is that he was protected by more walls from the radiation.

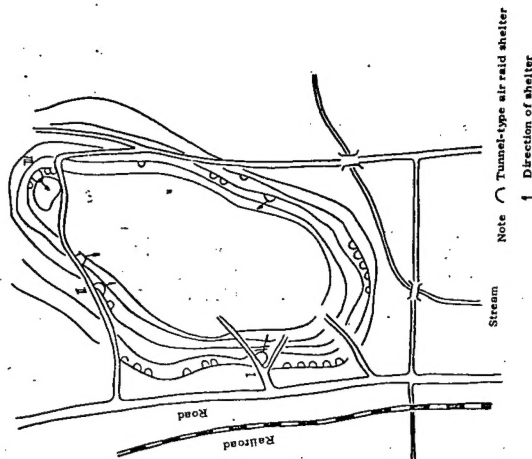
Fig. 1. Prison hill.

The Nagasaki Prison is located near the epicenter of the atomic bomb explosion. As a result, most of the people in this vicinity were killed instantaneously. The prison itself is located on a rise about 50 m above the surrounding plain. Several tunnel-type air raid shelters were dug into the side of this rise about the periphery. A few who were engaged in repair work and a few who by chance happened to be in the tunnel survived the blast. The air raid shelters dug into this hill were as shown in Fig. 1. Seven people in Shelter No. 1, one in Shelter No. 2, and two in Shelter No. 3 or a total of ten survivors were counted.

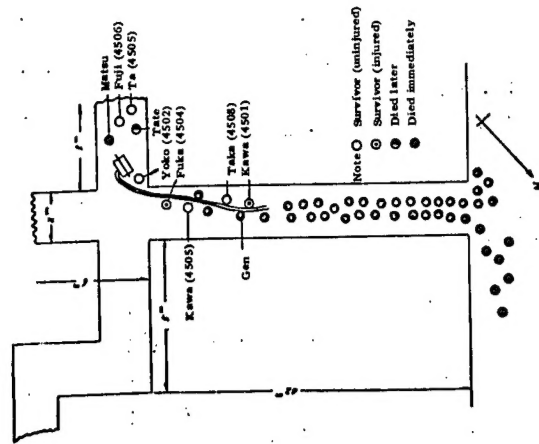
Fig. 2. No. 1 Air Raid Shelter.

This is the largest shelter located on the west slope at about the same altitude as the road. At the time of the Blast, 52 men and women were engaged in removing water that had leaked into this shelter. Those deepest in the shelter were using hand pumps which sent the water out part way through a pipe from which point a bucket relay brought the water all the way out. The distances from the entrance are shown in Fig. 2.

All the people from the entrance to about halfway into the tunnel died, and the seven who were further in survived. The location of these survivors are shown on this chart. The types of injuries suffered by these survivors are listed in Table 1. The survivors related the morning after the explosion that there were about 40 dead bodies between the entrance and the halfway mark. Some had been burned, some had been bruised, others had internal organs exposed, and

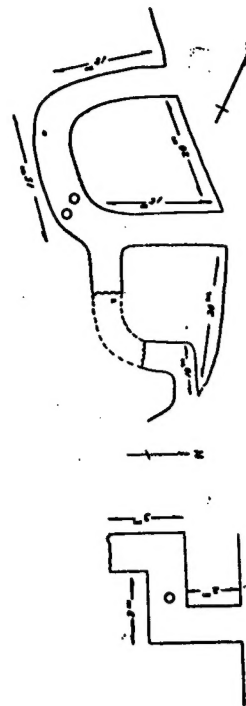
Fig. 3. No. 2 Air Raid Shelter.

This is a small shelter dug part way up the north slope (see Fig. 3). A girl had gone into this shelter to escape the heat temporarily and was in the spot shown in the figure. This girl received no wounds and was miraculously saved. She had fallen flat just about halfway into the shelter with her feet pointing toward the entrance, but all she received was the effect of a minor shock blast.
